Hood Insulation Chaffing on the Engine

Republished from <http://www.bullittarchive.com/>

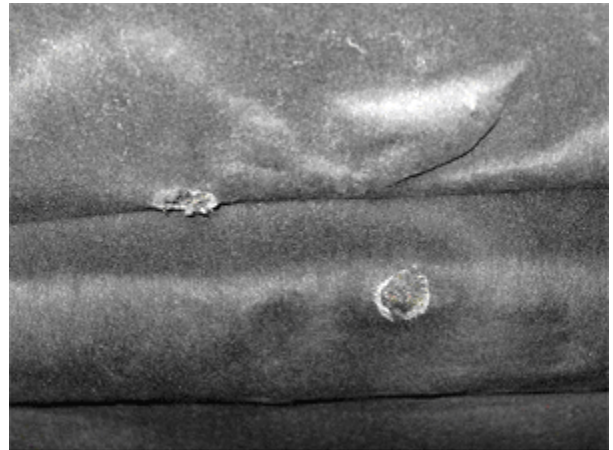
A common problem is that the idle air control (IAC) solenoid rubs against the hood insulation and will wear two holes next to the running pony. The problem is that the IAC hose and muffler sets too high and does not clear the insulation. There were several ways to prevent this. One way was to secure the IAC intake hose down to the alternator bracket. But this put a lot of stress on the short hose going from the IAC to the IAC muffler. What I did instead was to use a longer piece of 3/4" hose going from the IAC Solenoid to the intake hose muffler. This allowed the hose and muffler to set lower with out having to use hardware. I am sure Ford will change this as an extra 3 inches of 3/4" hose has to be a lot cheaper than having the warranty department change out the hood insulation.

Here is what the wear marks look like.

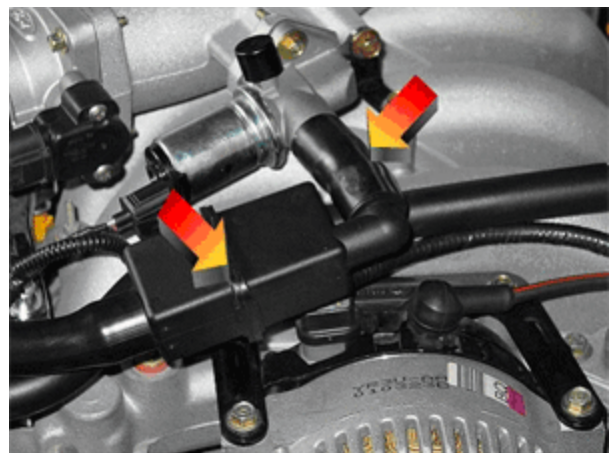
Here is how the IAC muffler and intake hose sets. The arrows are pointing to the areas that are contacting the insulation.

I tried adding a tie strap to the IAC muffler with the OEM short hose in place but it put too much tension on the shorter hose.

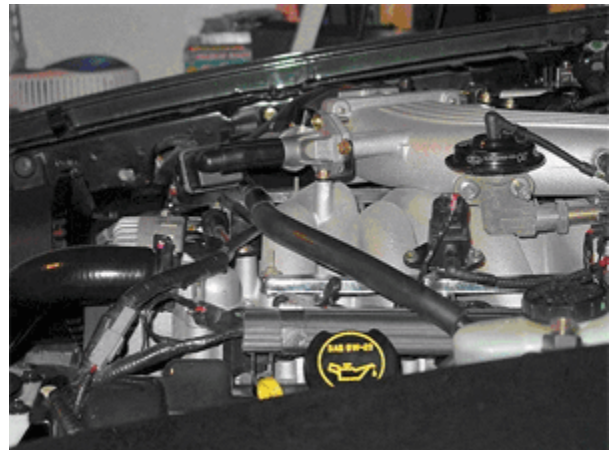
This is a view from the side before.

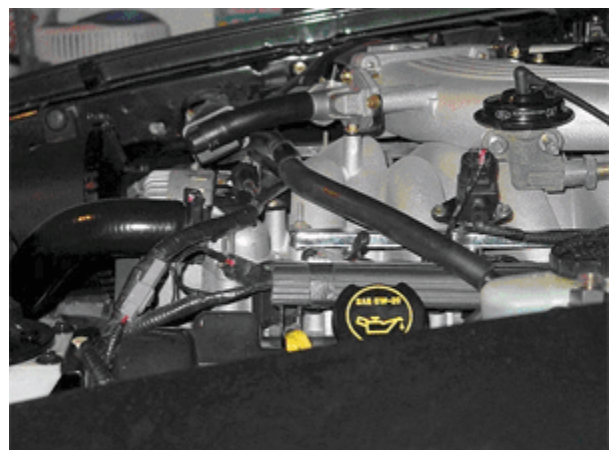
Another view from the side so you can see how much lower the muffler/intake hose sets now.
