Brake Light UV Damaged Repair

Republished from <http://www.bullittarchive.com/>

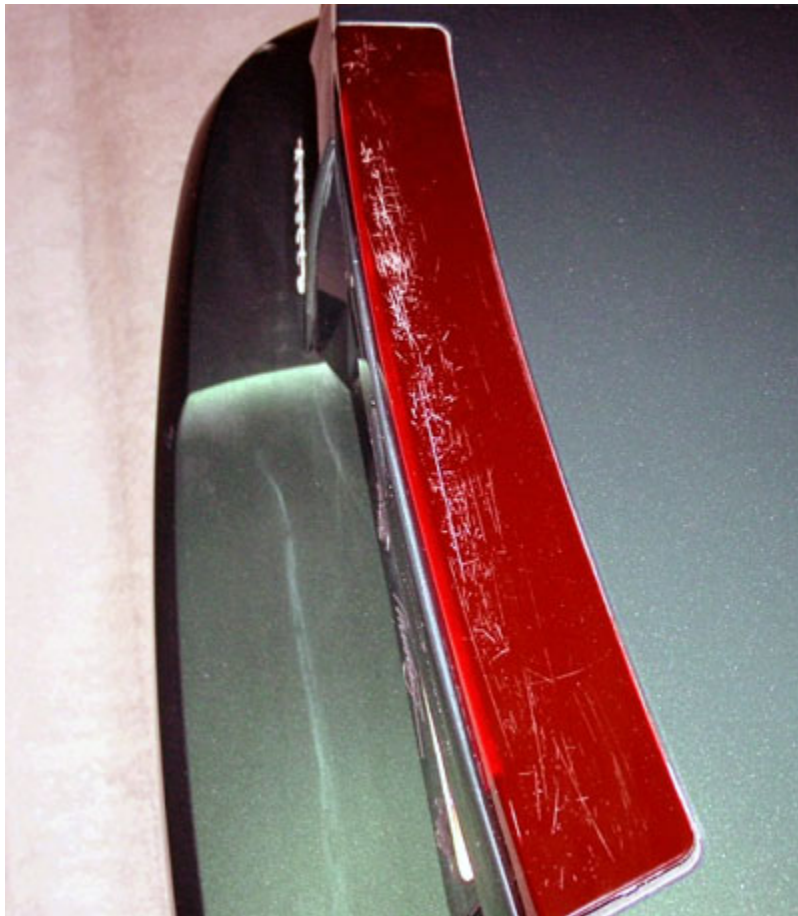
No, you did not scratch it nor did the neighbor kids do it, but our good friend the sun did. The UV light from the sun has started to deteriorate the plastic. The fact that the top of the brake light has a black backing to it may have helped it along. People that applied a polish to their car that offered UV protection may not have this problem.

This is what it looks like. NOT GOOD.

Many people have gone back to the dealer to have it replaced under warranty and Ford has replaced them. I try to avoid going to the dealer though and came up with the following solution.

The lens is pretty easy to remove. Remove the two 10mm nuts from inside the trunk. Lift the lens up and disconnect the electrical connector on the left hand side.

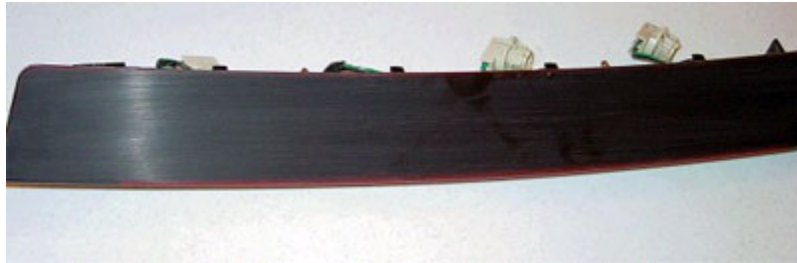
This is after about 20-30 minutes of sanding.

Making use of what I had around the house, I first used 320 wet sand paper. This will take the longest amount of time. You need to go deep enough to get past the scratches.

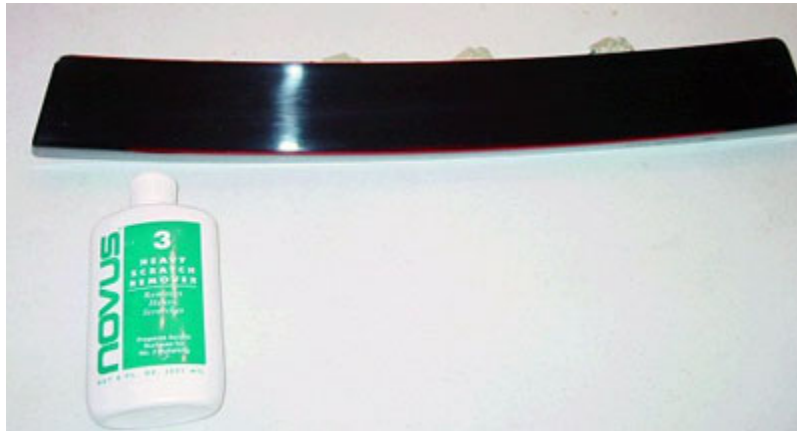
This is after about 3 applications of the #3.

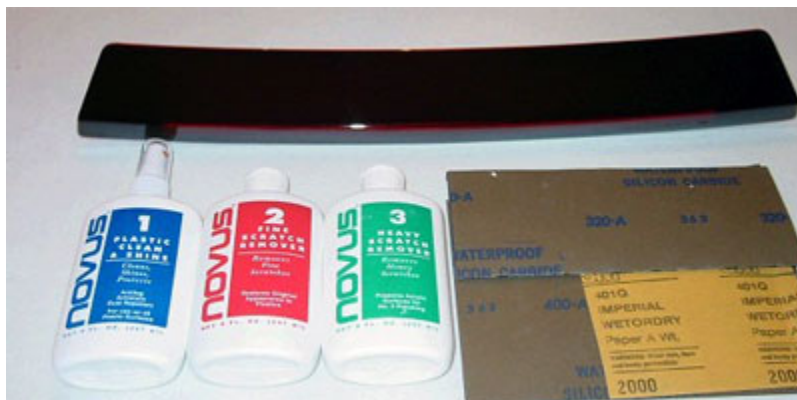
I then did a couple of applications of the #2 and then tried the #1. To tell you the truth I was pretty happy after just using the #3. This is after using only a couple applications of #3 #2 and then the #1. I will probably polish some more with the #1 when I have it in the sunlight.

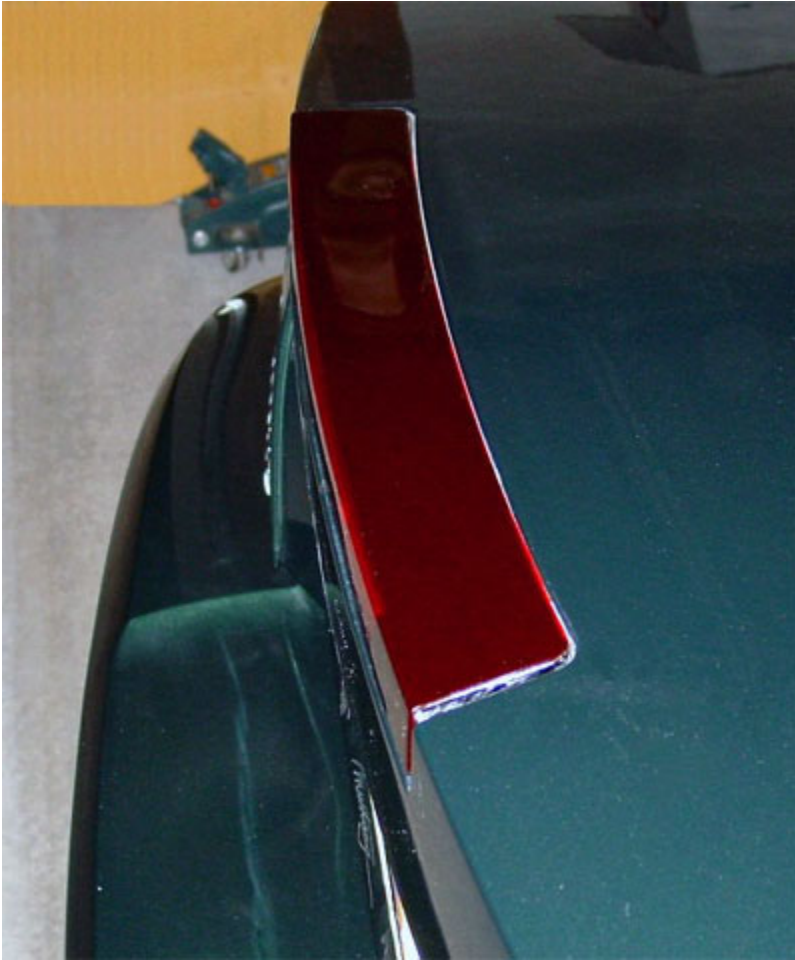
Not bad for about 30 minutes worth of work.

Can you tell a difference?
